A guide to sending BEN a container of bicycles

Sending BEN a container of bicycles

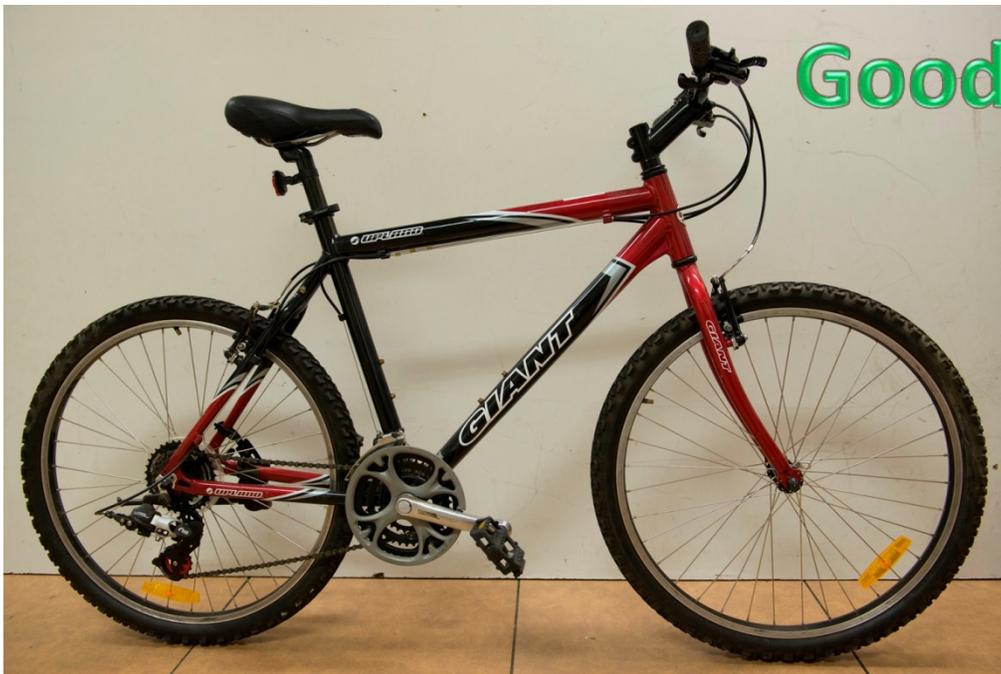
Good Condition

The general visual appearance of the bike is excellent, with all the major components intact.

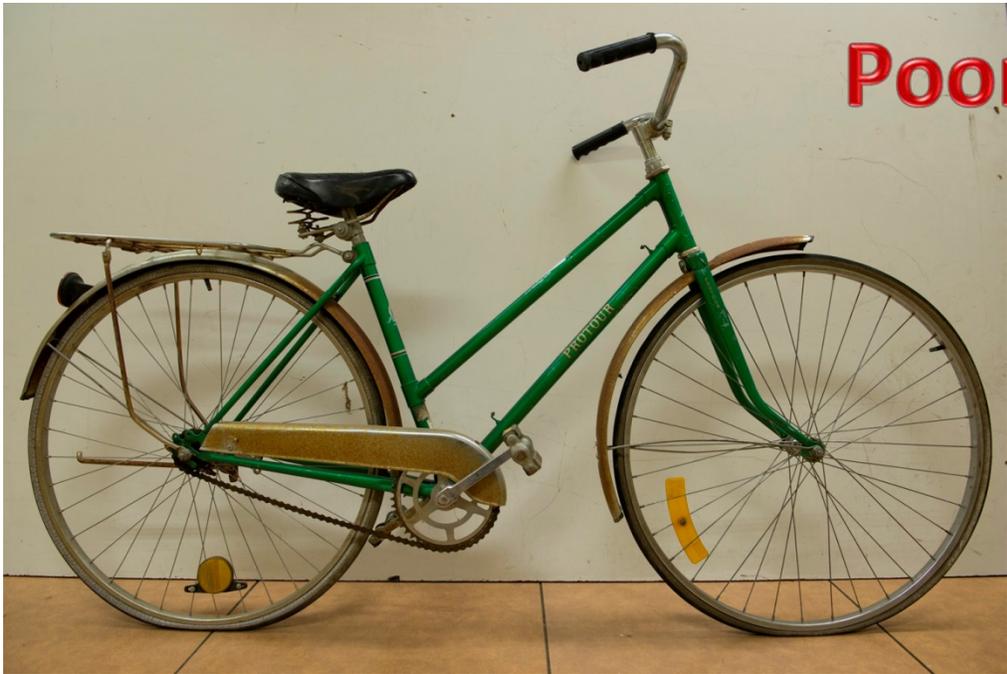
Poor Condition

This bicycle shows significant wear and tear and is badly rusted. Components such as the front brake are missing.

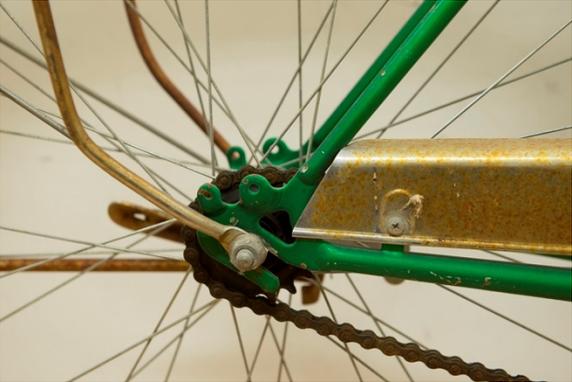
This bicycle has significant rust on most of its components. The drivetrain is dry and rusty, as are the stand, carrier and chain guard. This takes significant resources to remedy.

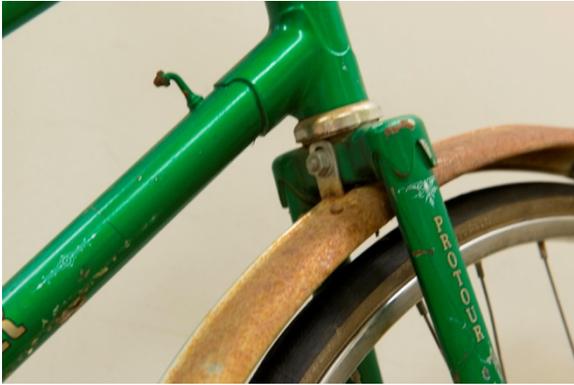
Key elements of this bicycle are damaged by rust. The headset is rusted, impacting on the safety of the bike. Front brakes are not present.

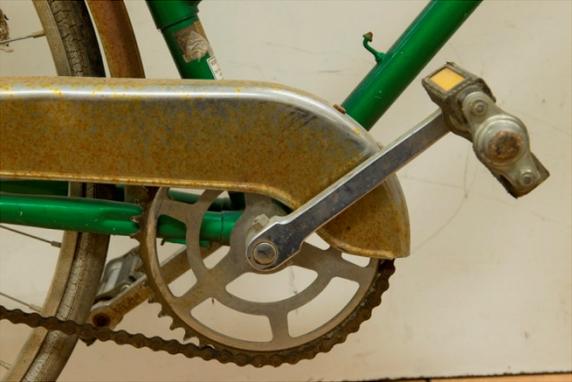
Significant rust can be found on the cranks, pedals, chainrings, mudguard and chain guard. The time and effort required to fix this severely undermines the value of this bike as a donation.
